Best Practices in Dam and Levee Safety Risk Analysis

Part H – Other Risks

Chapter H-2 Landslides

June 2017

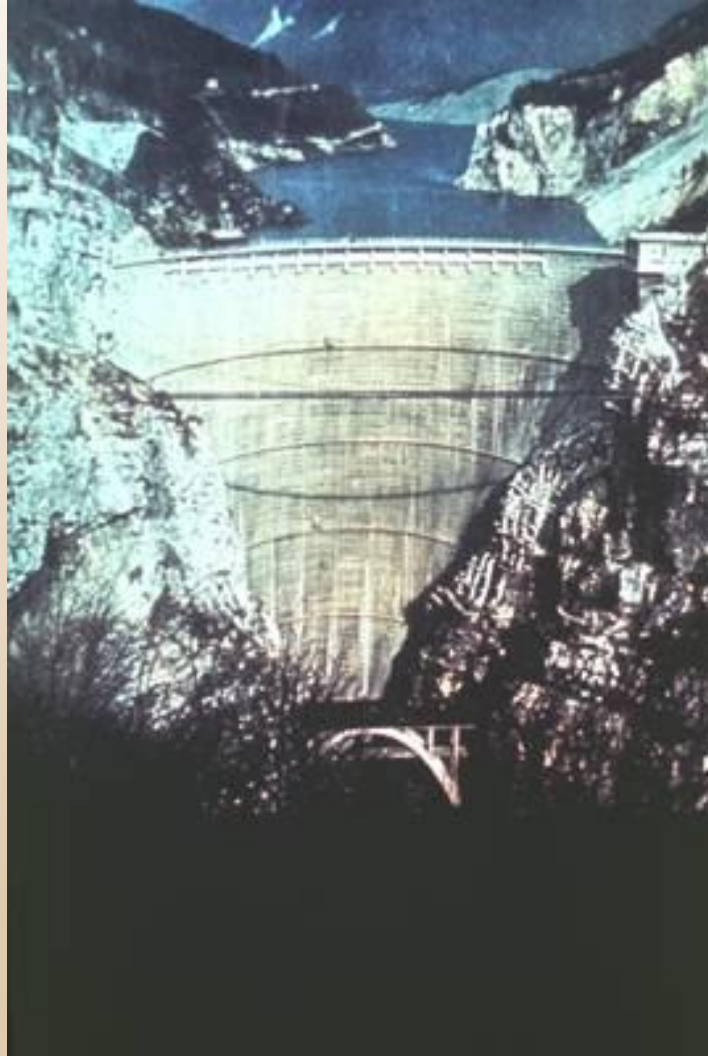
Vaiont Dam, Italy

- 870' high arch dam on Vaiont River near Longarone, Italy
- Completed in 1960
- The foundation and reservoir slopes composed of bedded limestone
- Left bank slide mass from post-glacial period

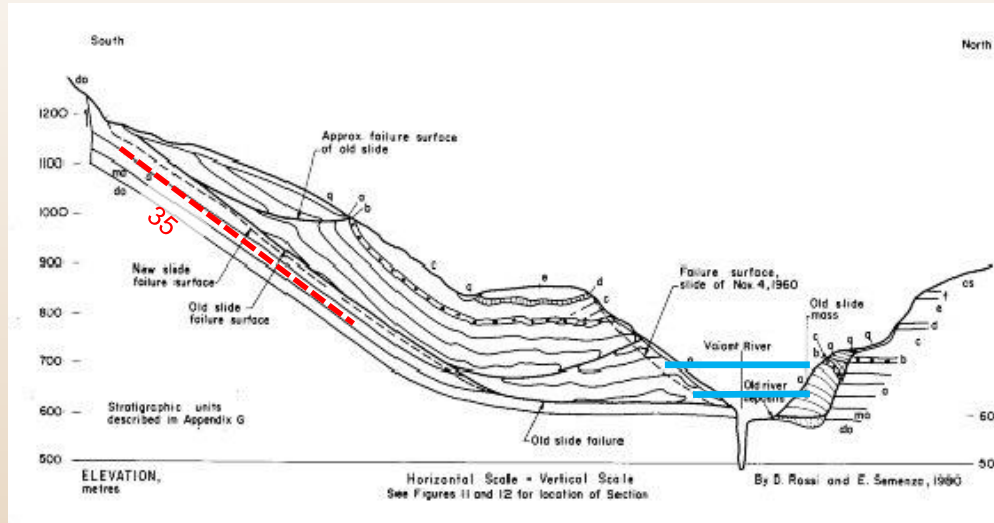
Vaiont Dam (Overtopping Wave)

- A part of the mountain side slid into the reservoir on Oct. 9, 1963
- Filled the entire reservoir for a mile upstream of the dam creating huge wave
- Sliding occurred on clay-filled bedding planes with $\phi = 10$ to 12° with dip of $35^\circ \pm$ to 0°
- Approx. 250 million yd^3

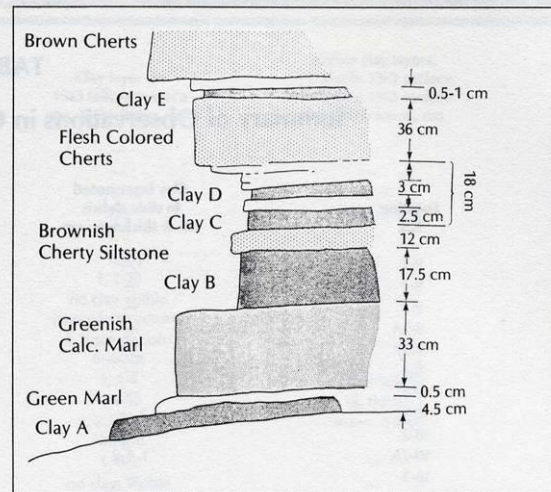
FIGURE 19. A sketch of the outcrop of Malm rocks southwest of Casso. This outcrop lies in the same stratigraphic sequence as those at the base of the Vaiont Slide.

Similar
sequence
outside slide
area

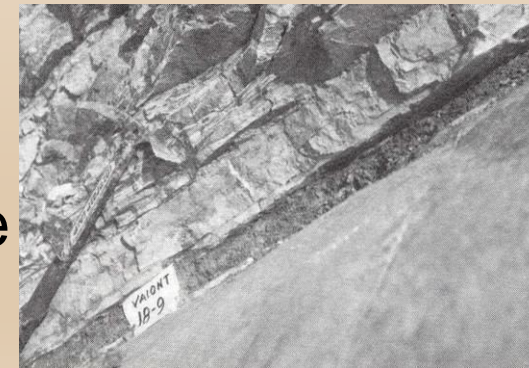
Clay layer at slide plane

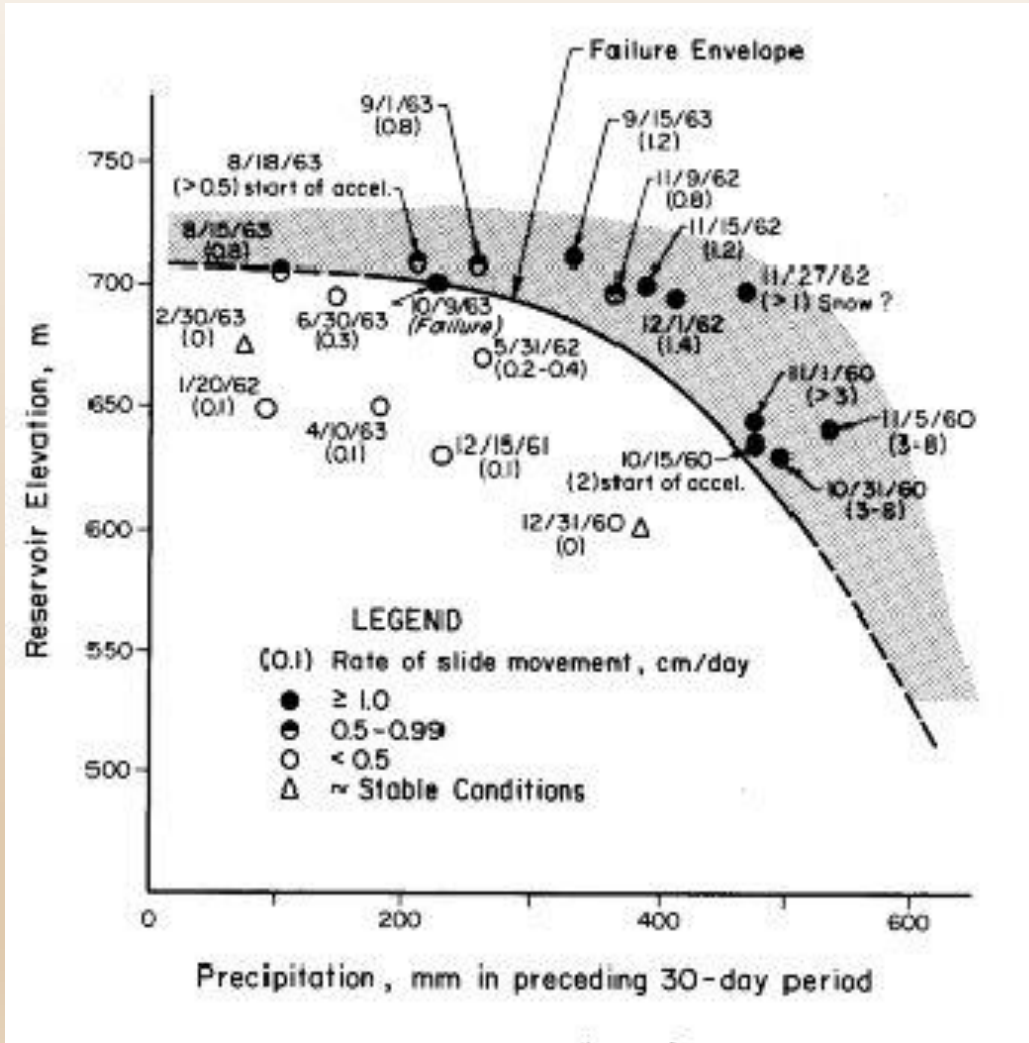
Vaiont Dam Landslide

Combination high reservoir and high rainfall caused slide

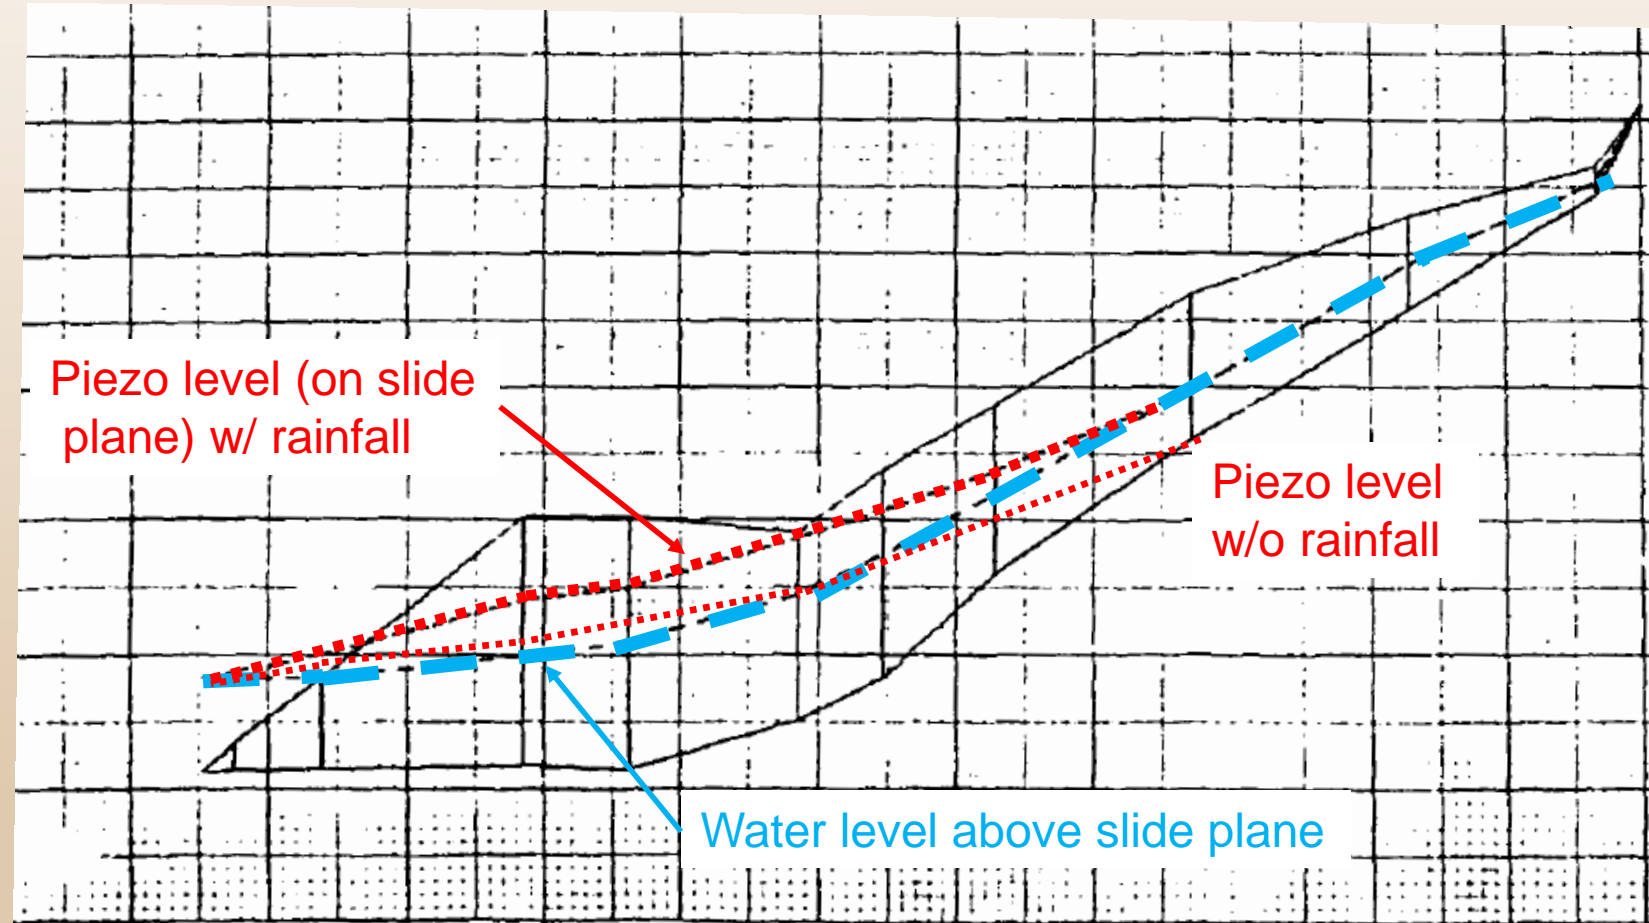
Res (m)	Rain	F.S.
710	High	1.00
710	Low	1.10
650	High	1.08
650	Low	1.18
None	High	1.12
None	Low	1.21

Vaiont Slide - Semenza Section 2, 710 m reservoir, October 1963, with rainfall

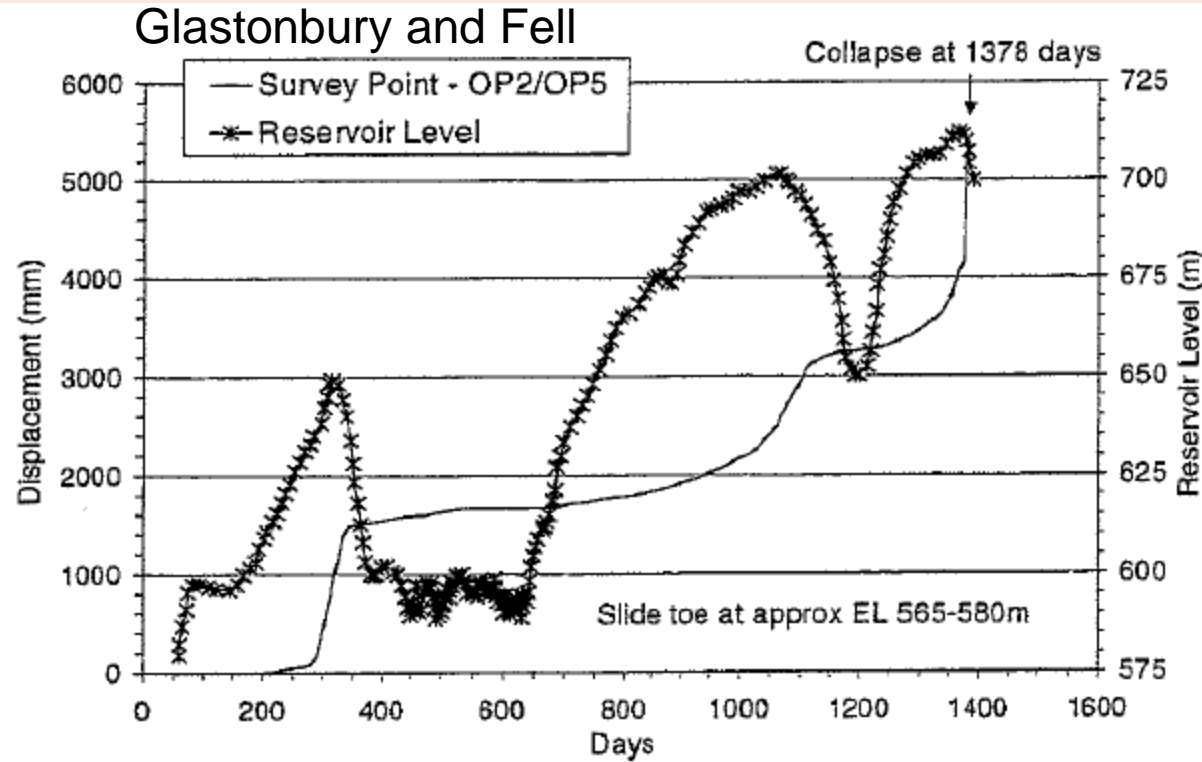
Displacement and Reservoir Level vs Time

Figure Q : Displacement-time data for Vaiont showing relationship with reservoir level (Data modified from Hendron and Patton, 1985).

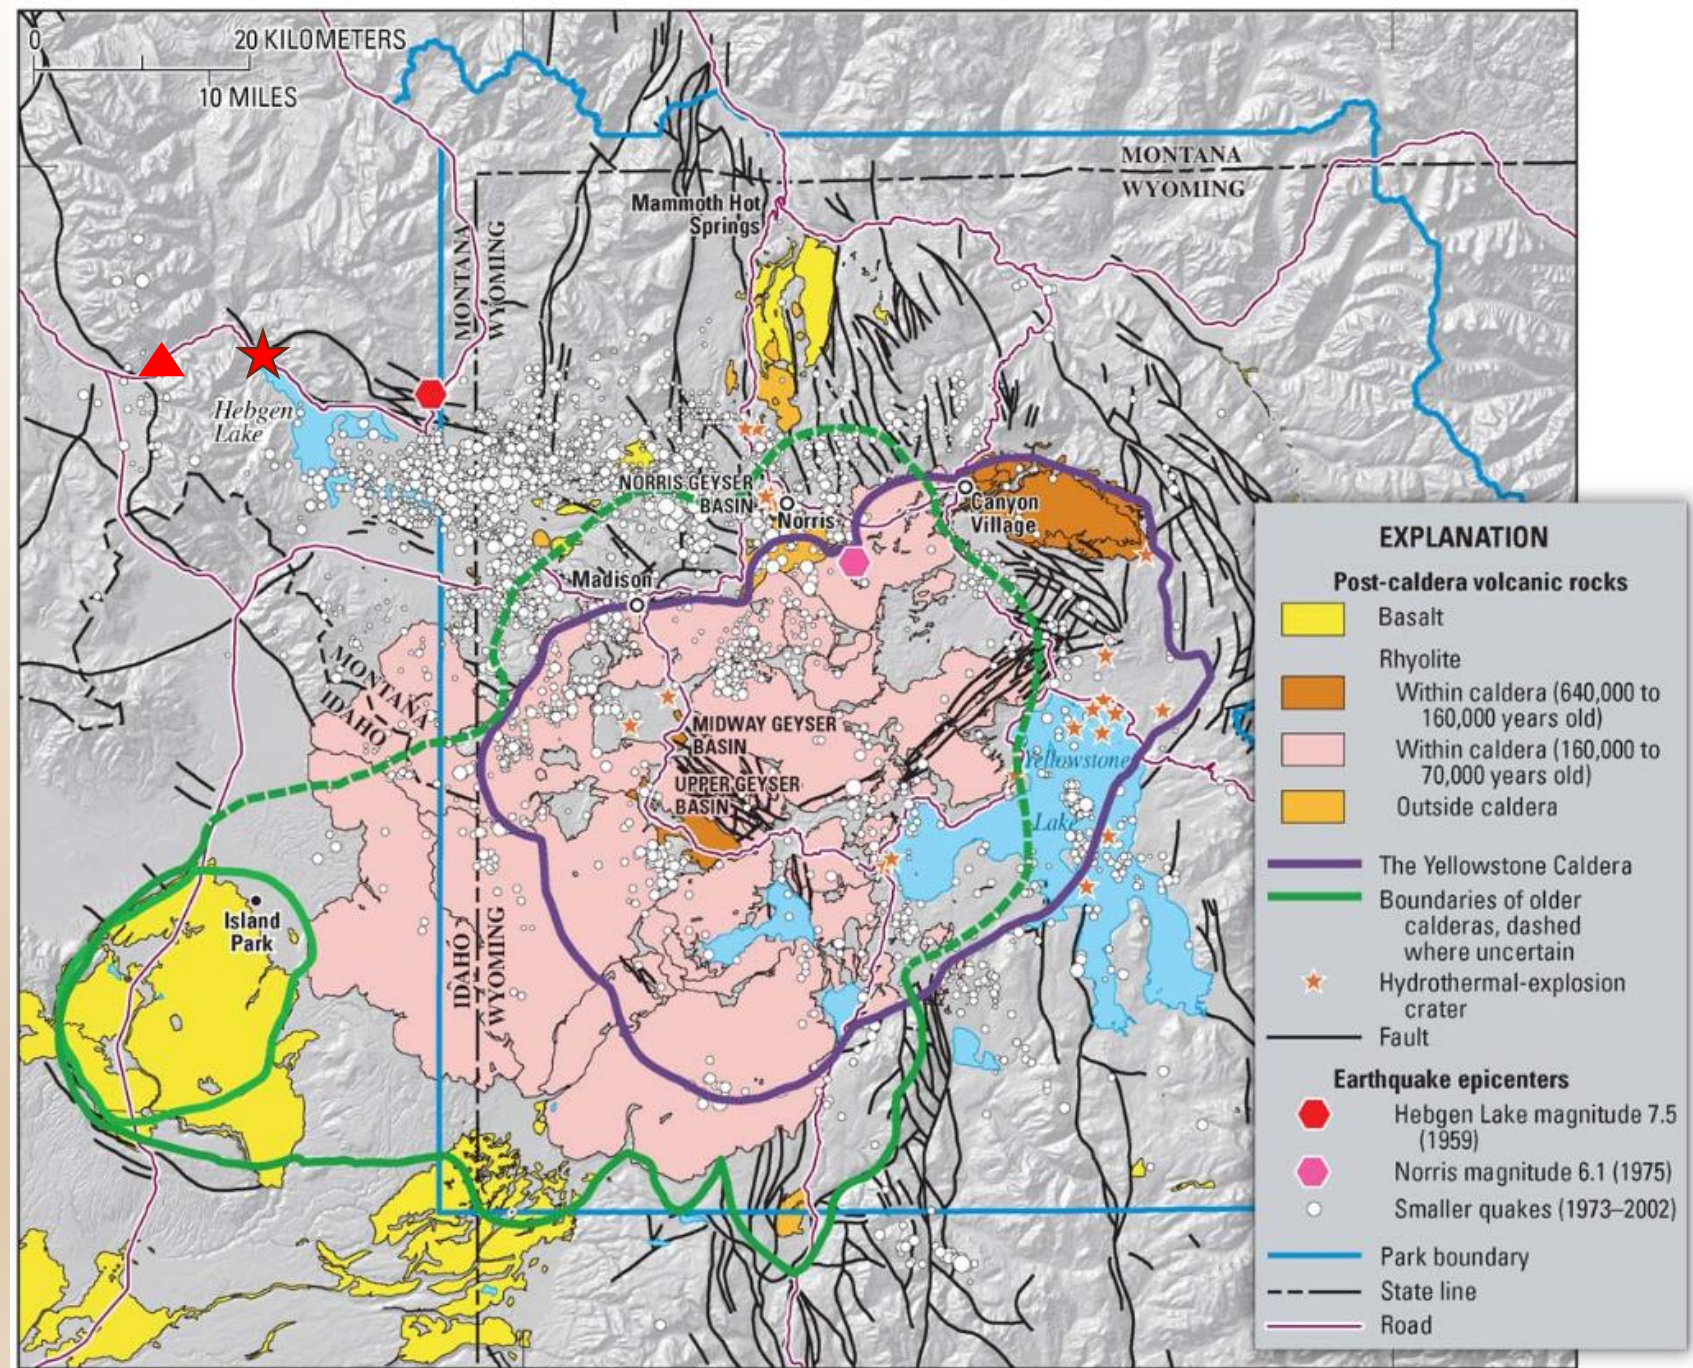
The Quake

- Magnitude 7.5
- Max Intensity X
- Lasted 30-40 secs
- Up to 20 feet vert. offset
- Epicenter ◆
- Dam ★
- Quake Lake ▲

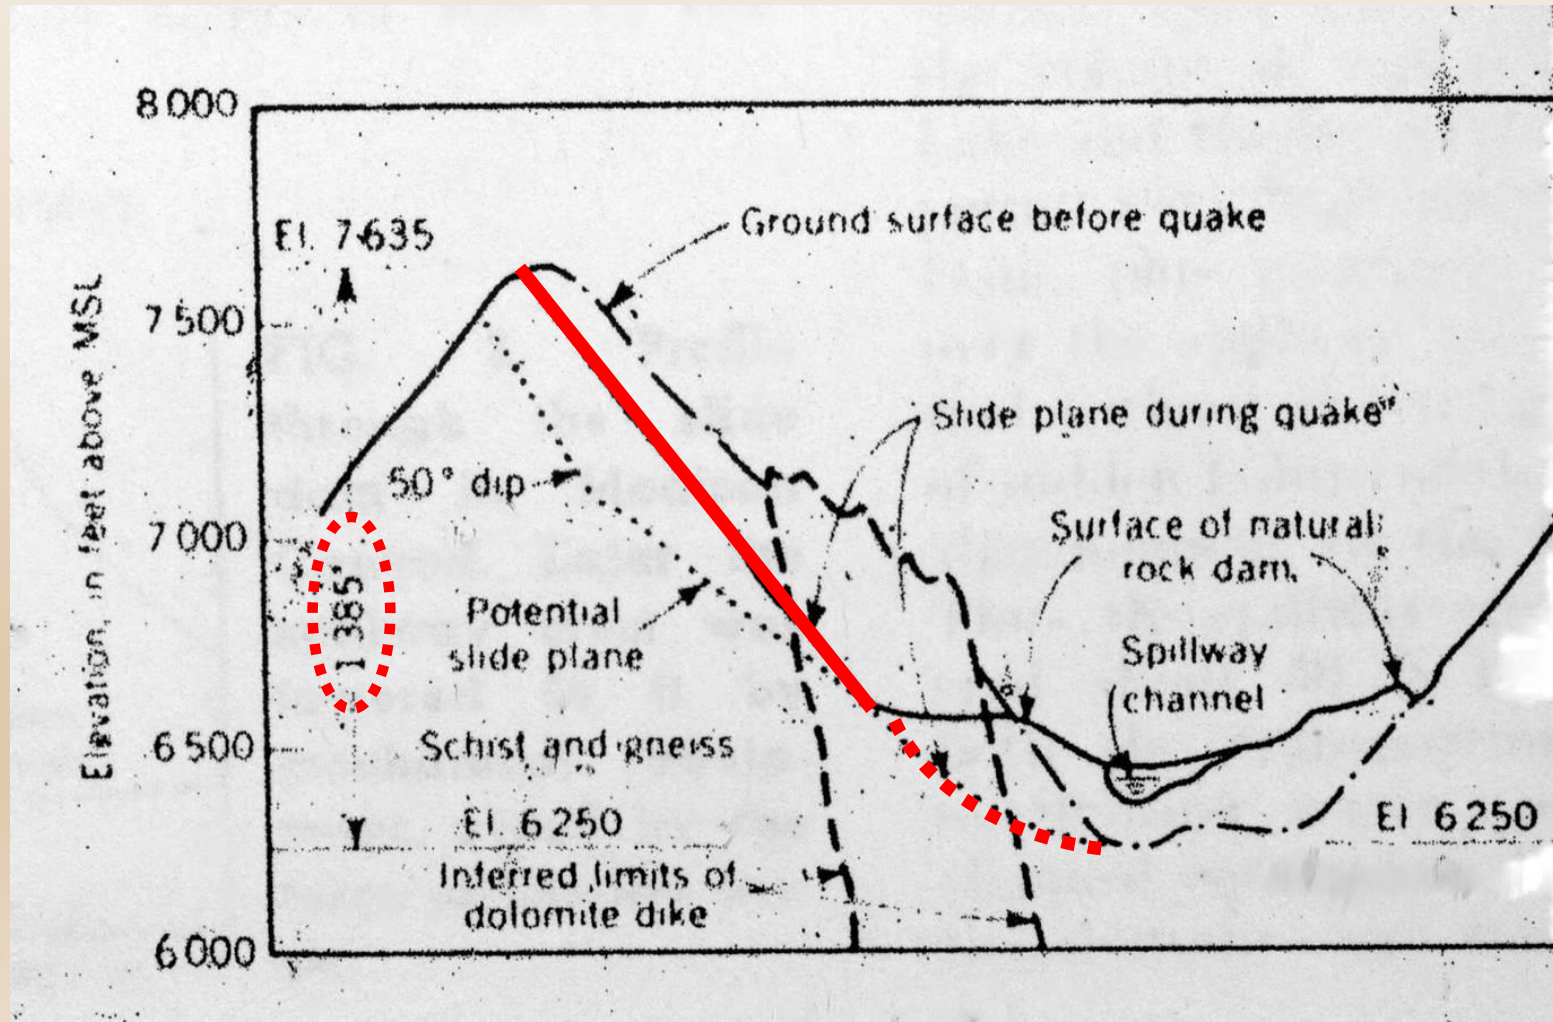
Quake Lake Landslide

- Buttress of jointed dolomite collapsed
- Sliding occurred along 50° foliation toward canyon
